**CITY OF LA VISTA  
MUNICIPAL FACILITIES PLAN**

**FINAL REPORT**

October 2008

**LEO A DALY**

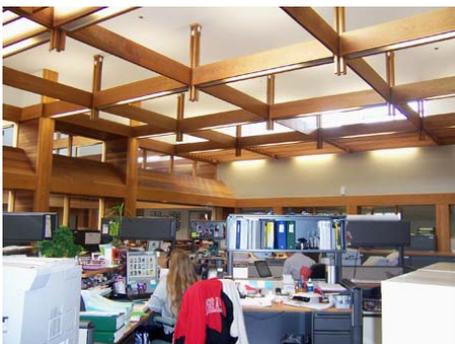
City hall front office is overcrowded and noisy.

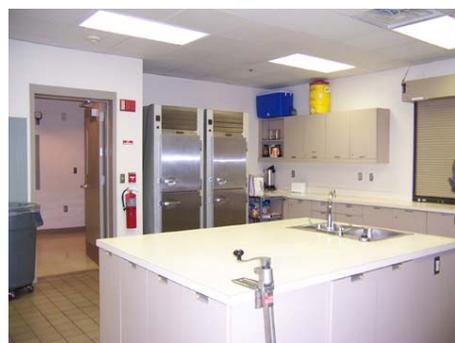
Senior Group would be better served if provided a dedicated space instead of sharing the Recreation Center kitchen and meeting rooms.

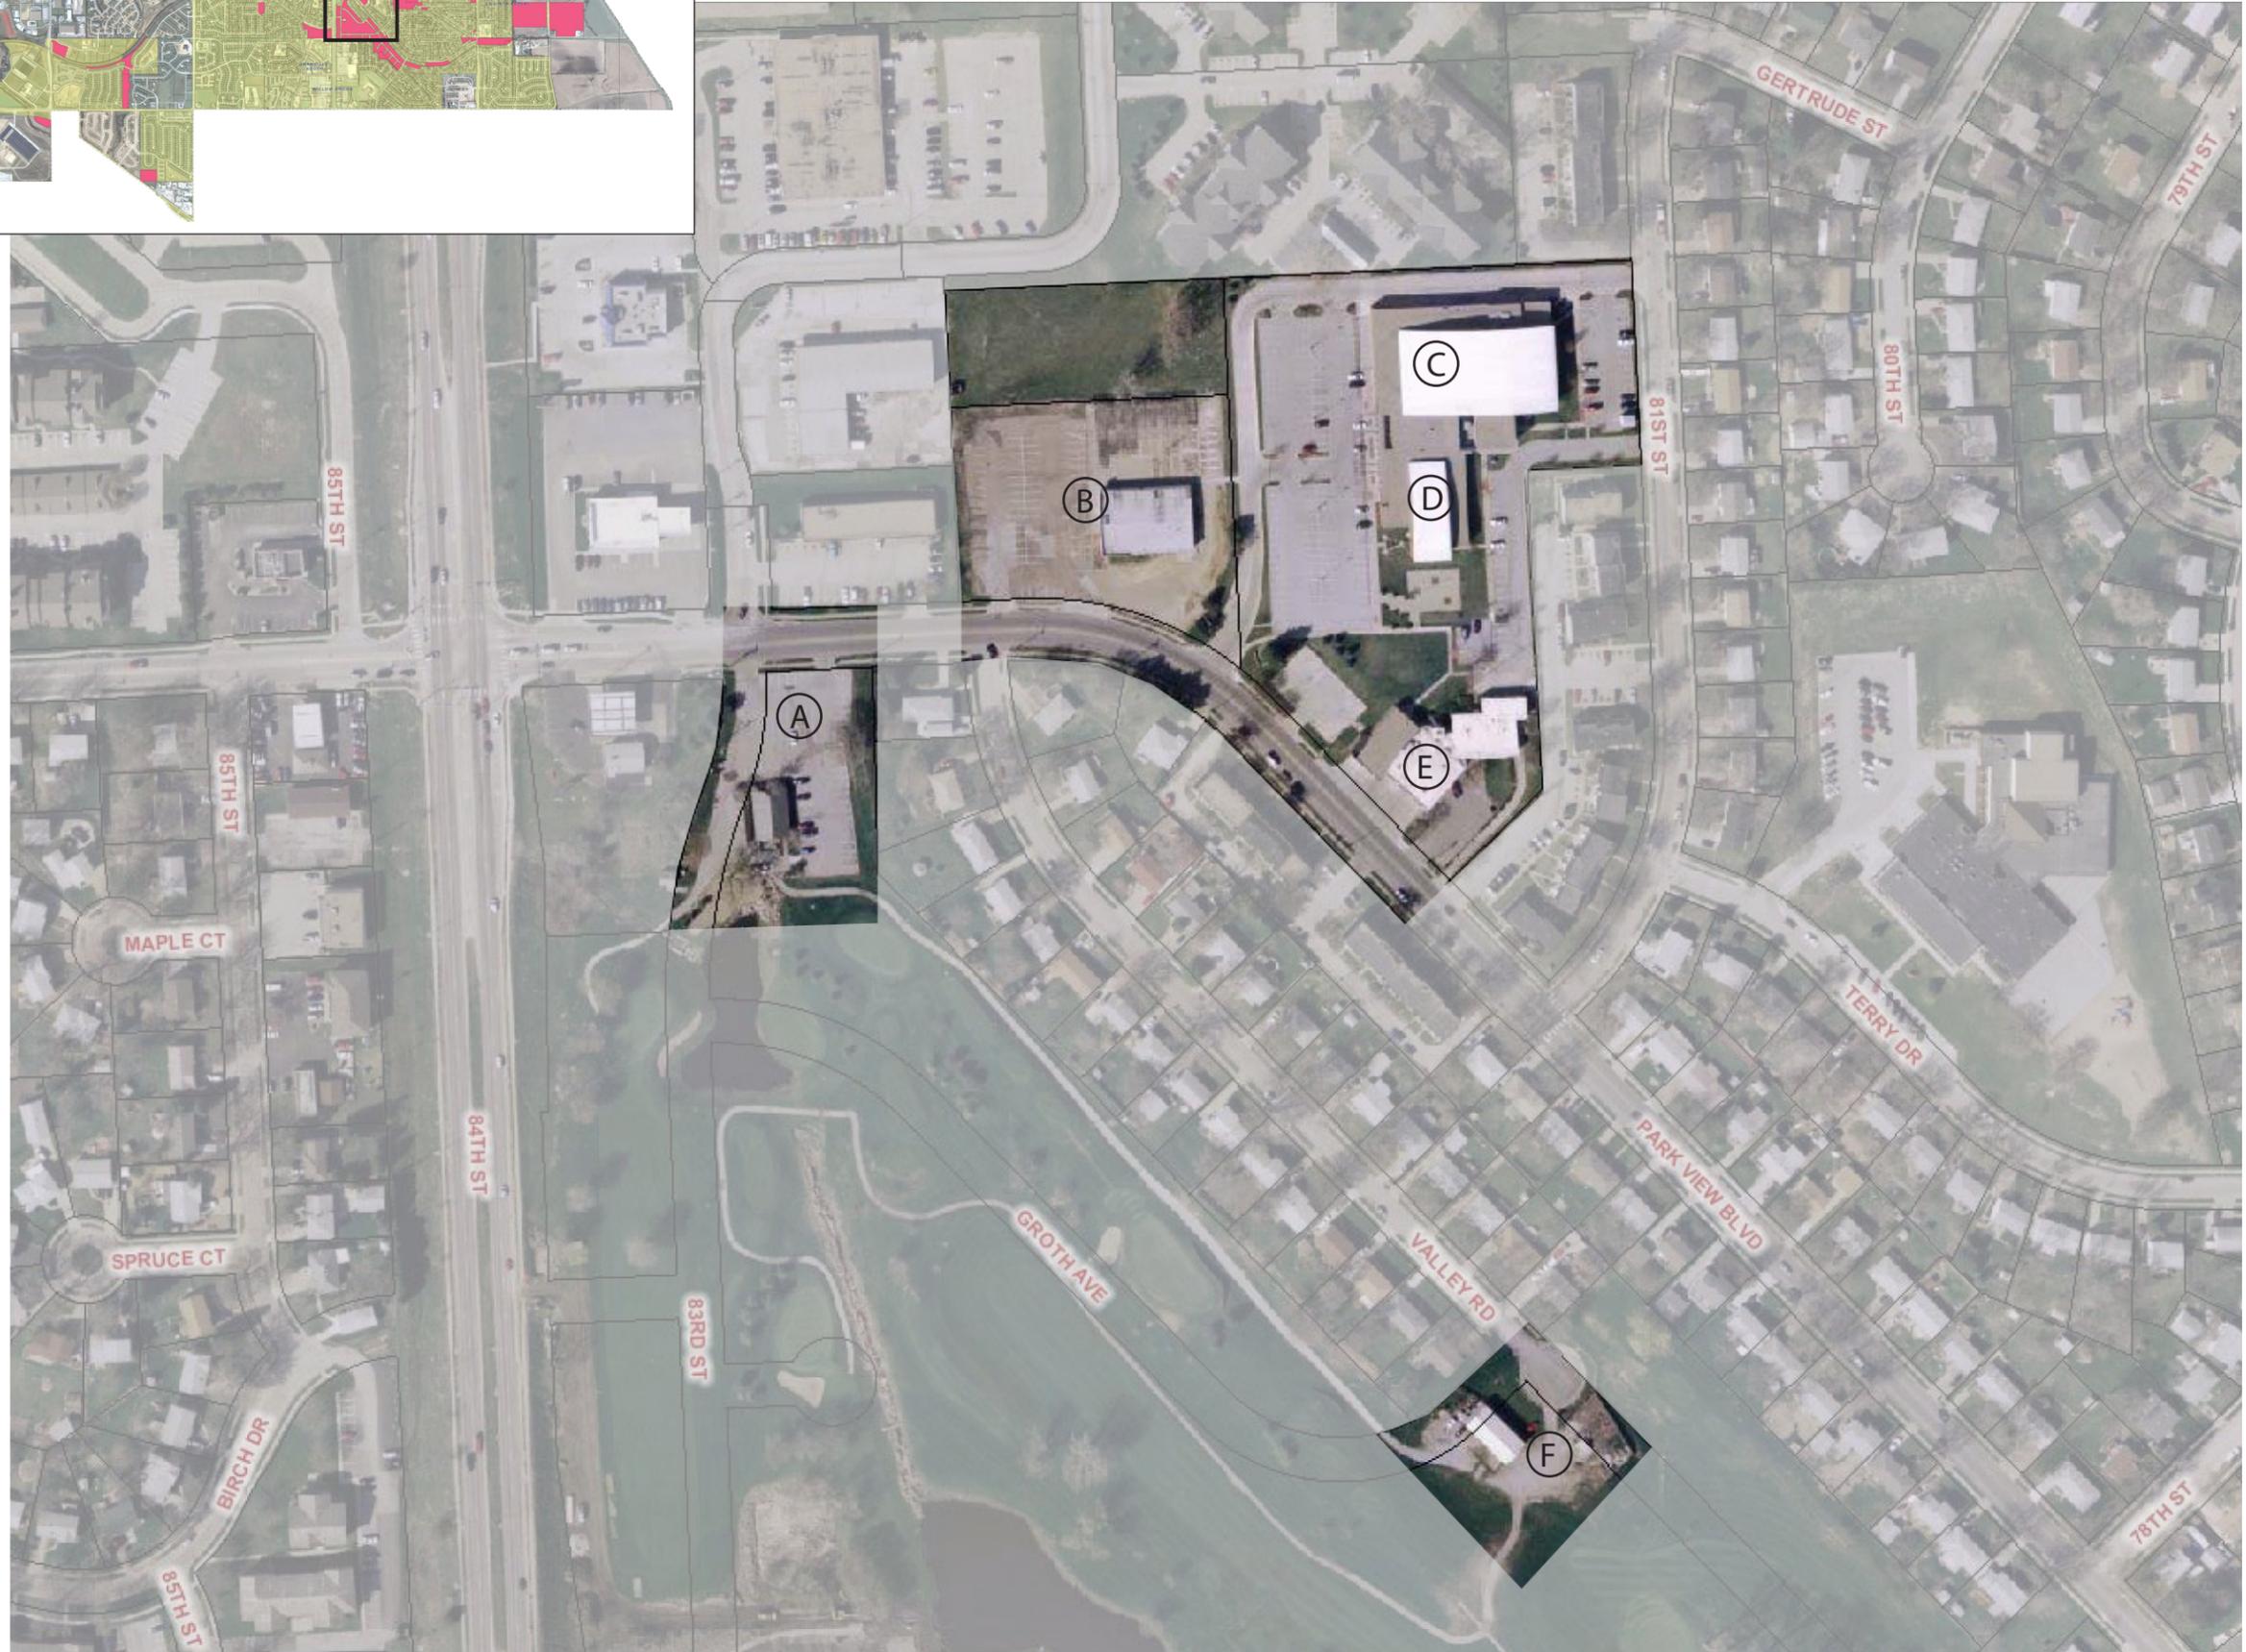
Approx. Scale 1:200

**Property List**

- A. Golf Clubhouse
- B. City Owned Property  
(Building and parking lot has been removed)
- C. Recreation Center
- D. City Hall
- E. Fire Station #1 (with Former Police Station)
- F. Golf Maintenance Facility

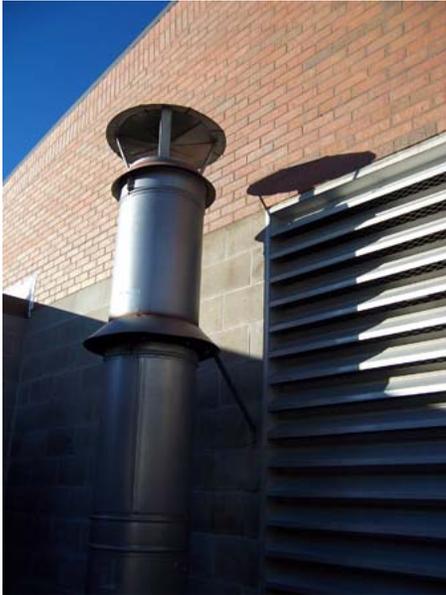
Boiler flue for the City Hall/Recreation Center should be extended so that it terminates two feet above the roof line.

- **Boiler Flue:** The boiler flue terminates adjacent to the building and below the roof line as shown on the photograph. NFPA 54 requires that flues from gas fired appliances terminate two feet above anything within 10 feet. Therefore, the flue needs to be raised to two feet above the roof or routed away from the building wall 10 feet.

<b>Priority 1: Code Deficiency/Life Safety Projects</b>			
<b>Project Description</b>	<b>Building</b>	<b>Category</b>	<b>Cost Estimate</b>
* Boiler flue termination extention	City Hall/ Recreation Center	Code Deficiency/Life Safety	\$1,000 - 1,500

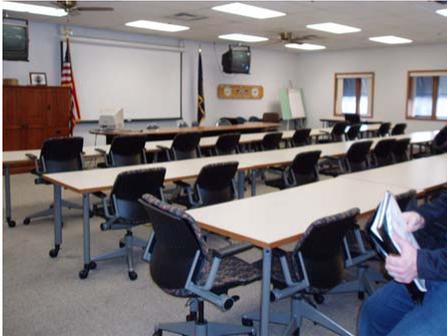
Training room and training officers are located in a different level of the building and disconnected from the rest of the station.

- Multiple additions have created a hodge-podge of spaces, lacks flow, hidden/difficult to find entrances, training room and training offices remote from rest of facility

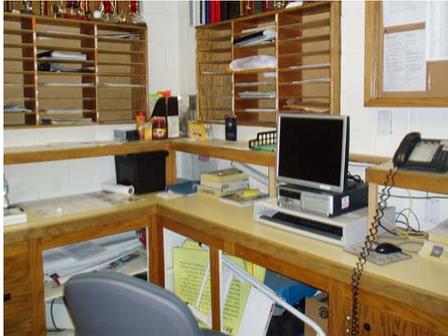
Office space lacks privacy and has poor air quality due to the inefficiency of exhaust system in adjacent apparatus room.

- **Apparatus Room Ventilation:** Ventilation of the Apparatus room is currently adjacent to supply fans and relief hoods. The supply fans are over pressurizing the space sending diesel fumes into the building when the fire trucks start up. This system is in violation of NFPA codes. A new system could be installed that would exhaust 6 air changes/hour from the space. These exhaust fans would be located on the roof. To prevent freezing, an indirect gas fired make-up air unit would also be located on the roof. The make-up air unit would be sized to deliver slightly less than the exhaust air flow to maintain a negative pressure in the space.

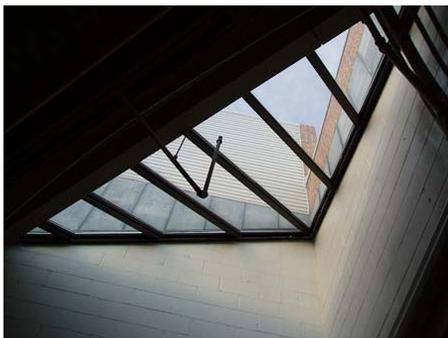
- Skylights in apparatus bay leak
- Underutilized space in old police office
- No Emergency Operations Center
- Tool room too small
- Not ideal for hosting firehouse tours, open house events, public education or fund-raising events

Skylights in apparatus room are prone to leaks.

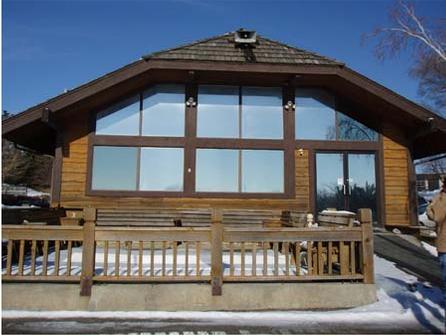
Large south facing windows on clubhouse are contributing to the heat gain problem making it difficult to maintain a comfortable temperature during the summer.

- **Cooling Problems:** Modify the existing building envelope and HVAC system. The existing HVAC system cannot handle the cooling load due heat gain associated with the large expanse of glass on the south side. Architectural remedies such as an extension of the roof overhang should be considered. Additional split system furnaces can also be added in order to accommodate the cooling load.

- Recommend extension of roof overhang on south side of clubhouse to shade windows from summer sun and reduce heat gain/cooling load.
- Clubhouse meets minimum needs of the golf course
- Additional golf carts needed due to increase demand (25% increase last year) – no additional storage capacity.
- Kitchen facilities limit food service possibilities
- Small merchandising area/pro shop
- No locker rooms for golfers
- Restrooms small and out of date/appears dingy

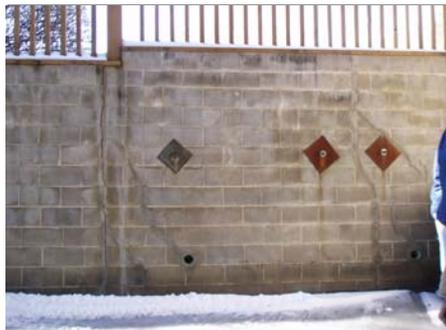
Retaining wall at golf clubhouse is not structurally sound.

- **Retaining Wall:** Retaining wall at golf cart ramp is not structurally sound and needs to be replaced.
- **Ramp Drainage:** Drainage in ramped area needs to be re-directed from sanitary sewer to storm sewer or day light to nearby pond.
- **ADA:** ADA accessibility at the Golf Club House Entrance needs to be provided.

* Entrance/Exits: ADA ramp repairs, Fire exit rail/curb fix	City Hall/ Recreation Center	Code Deficiency/Life Safety	\$15,000 - 20,000
Clubhouse golf cart ramp repairs: correct water pooling at bottom of ramp and structural retaining wall.	Golf Course Clubhouse	Code Deficiency/Life Safety	\$60,000 - 75,000
Alternative Clubhouse golf cart ramp repair: Correct water pooling at bottom of ramp and build "bracing deck" over northern 2/3 of ramp. Identify "No Parking" zone.			\$25,000 - 40,000
Site Improvements: New concrete apron with equipment wash water collection	Golf Course Maintenance	Code Deficiency/Life Safety	\$3,000 - 6,000

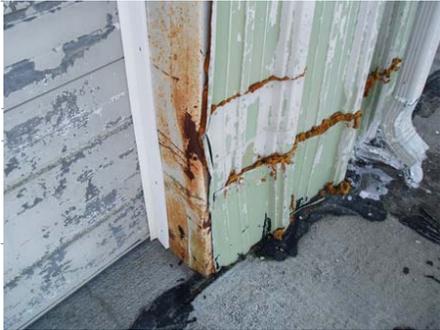
The sewer equipment has minimal clearance which results in occasional damage to the building and vehicle. This risk would be minimized by designing a new facility to accommodate the large scale of sewer equipment.

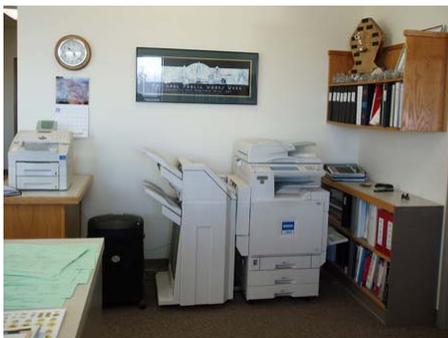
Copy and fax machines would be better located in a work room instead of the Public Works front office.

- Front office needs work room for copiers, fax, printers, files, etc – equipment is noisy
- Front office storage is undersized and located in janitor’s closet

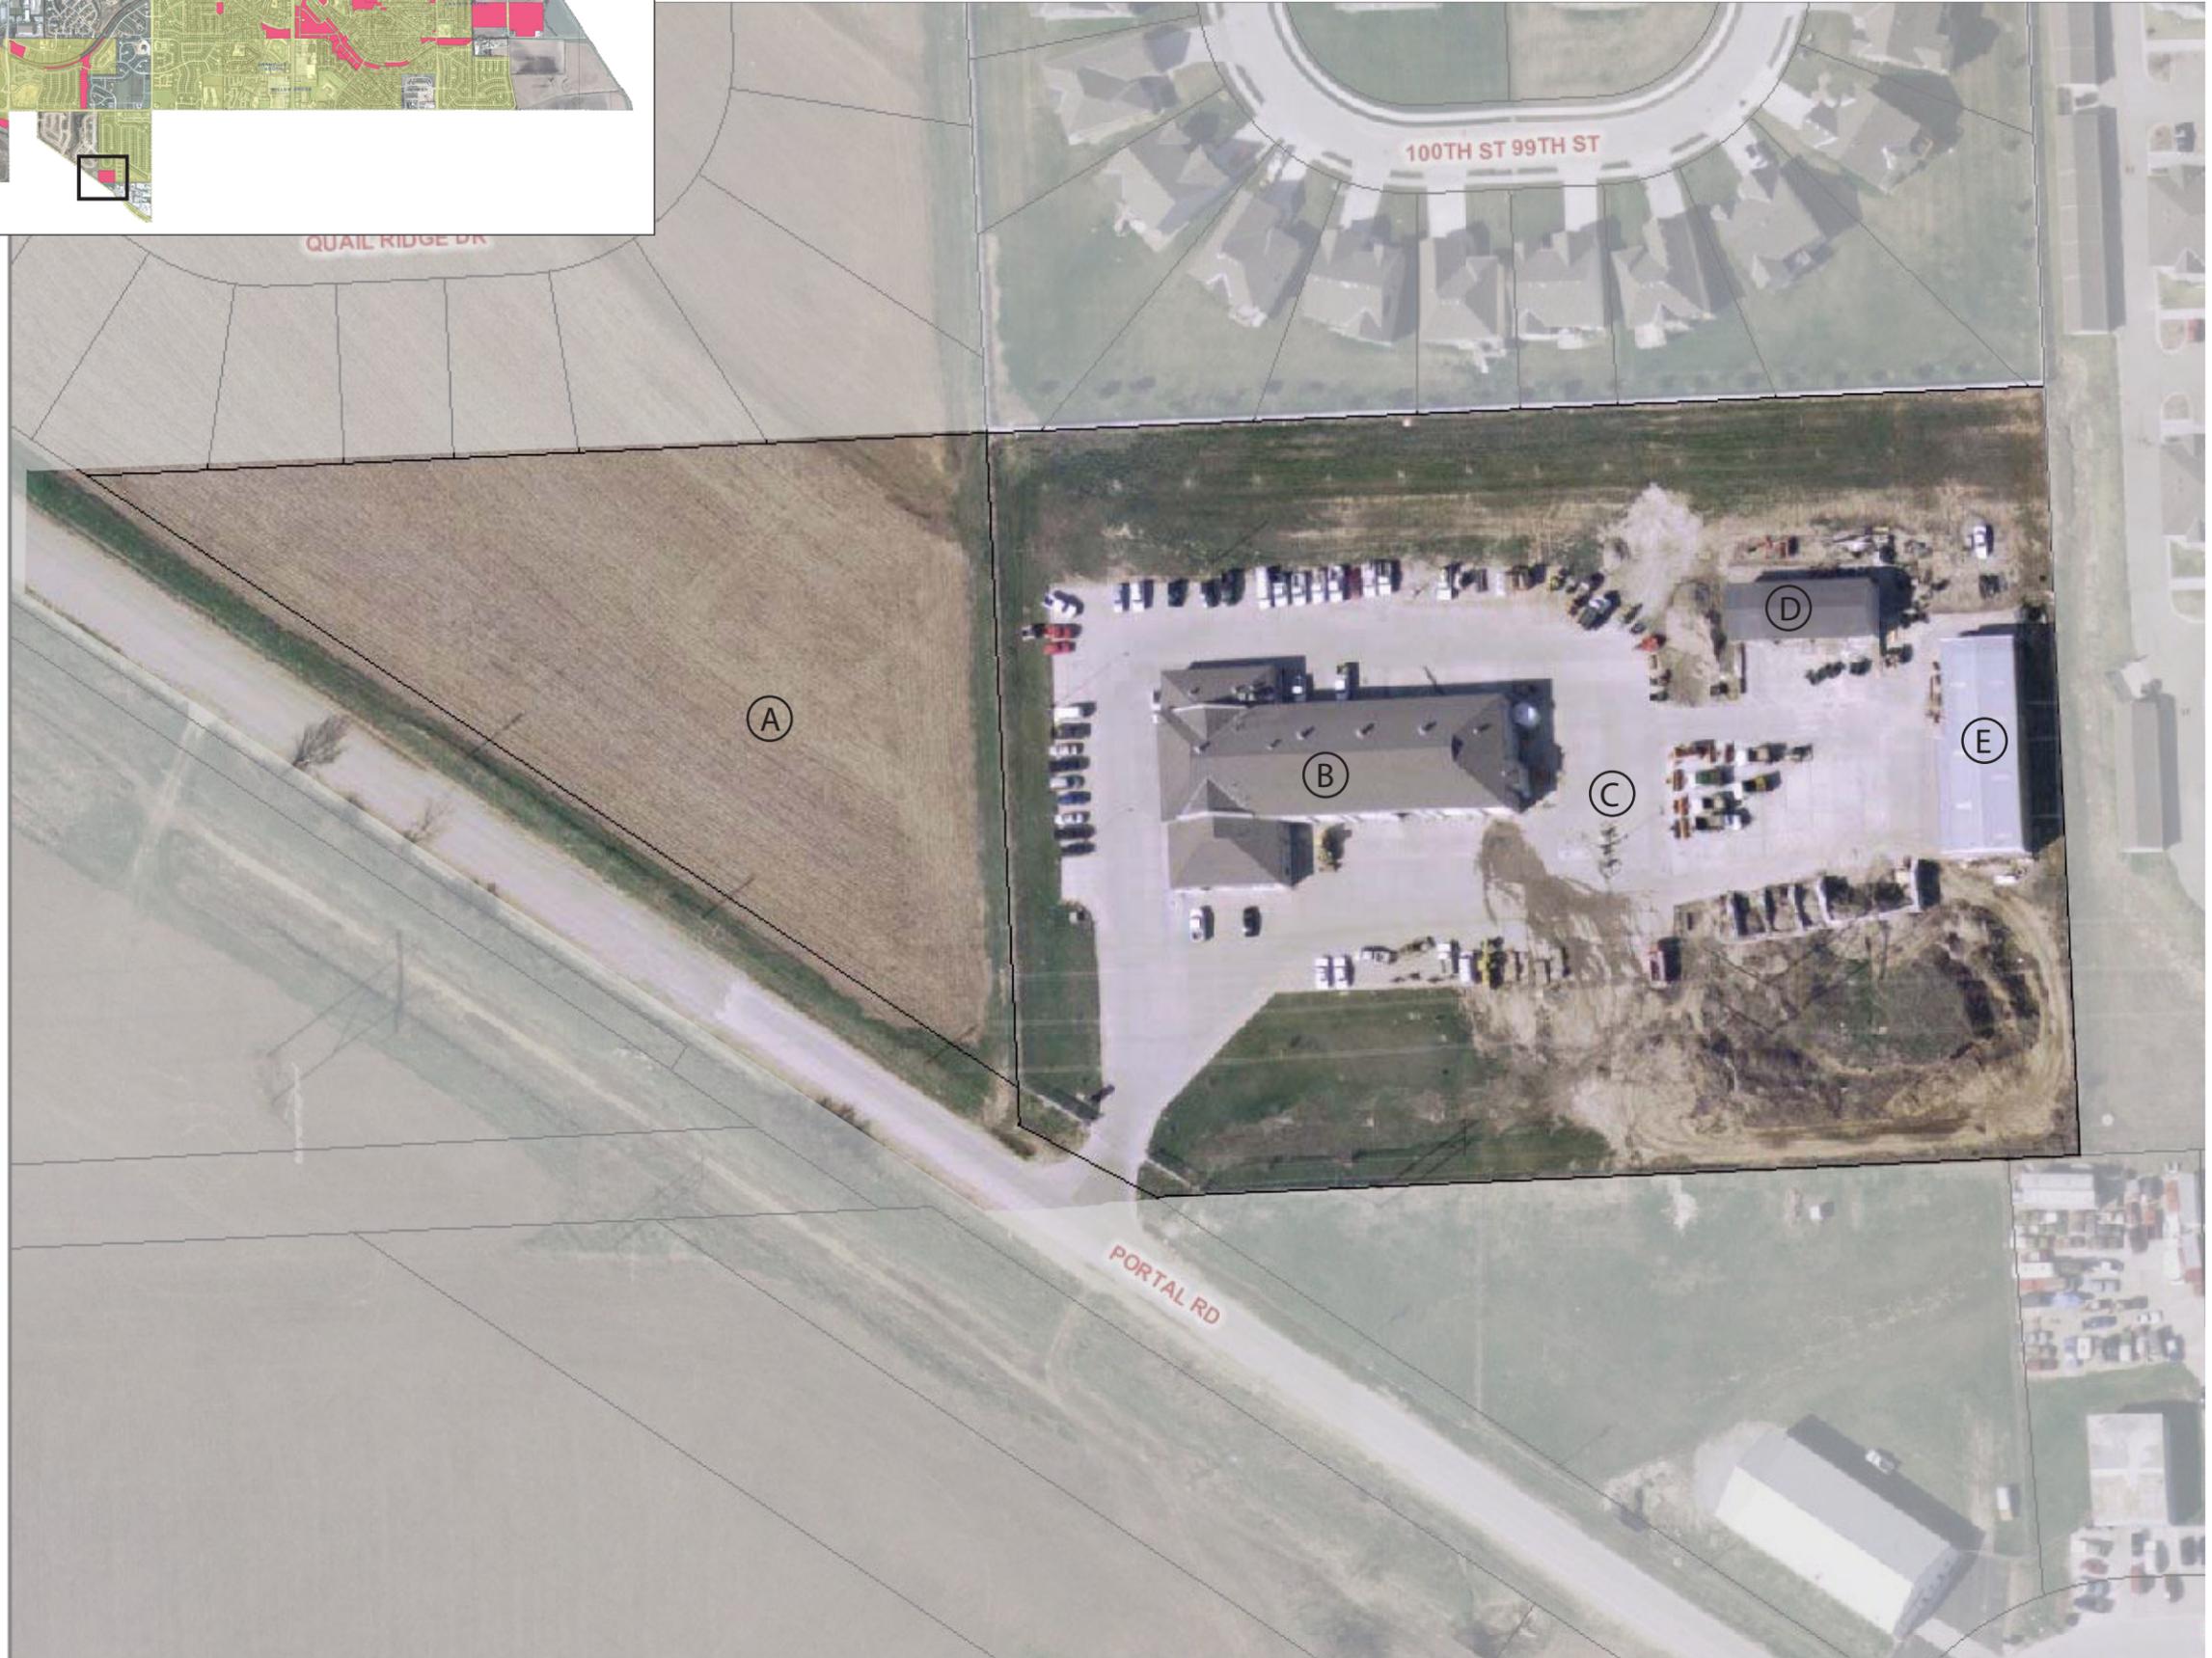
Approx. Scale 1:100

**Property List**

- A. Possible Expansion Property
- B. Public Works Building
- C. Fueling Station
- D. Salt and Sand Storage
- E. Sewer Division and Cold Storage Building

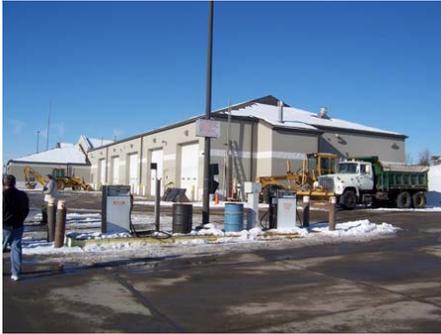
Fueling station and storage should have spill protection dike.

* Fueling Station: Install/construct fueling station spill dike	Public Works	Code Deficiency/Life Safety	\$30,000 - 40,000
* Storm water: Collect run off for salt/sand storage area	Public Works	Code Deficiency/Life Safety	\$50,000 - 70,000

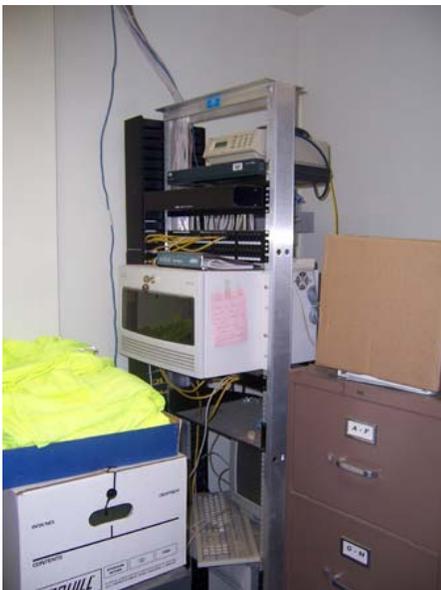
Server room is also used for storage, due to security issues access to the server should be restricted.

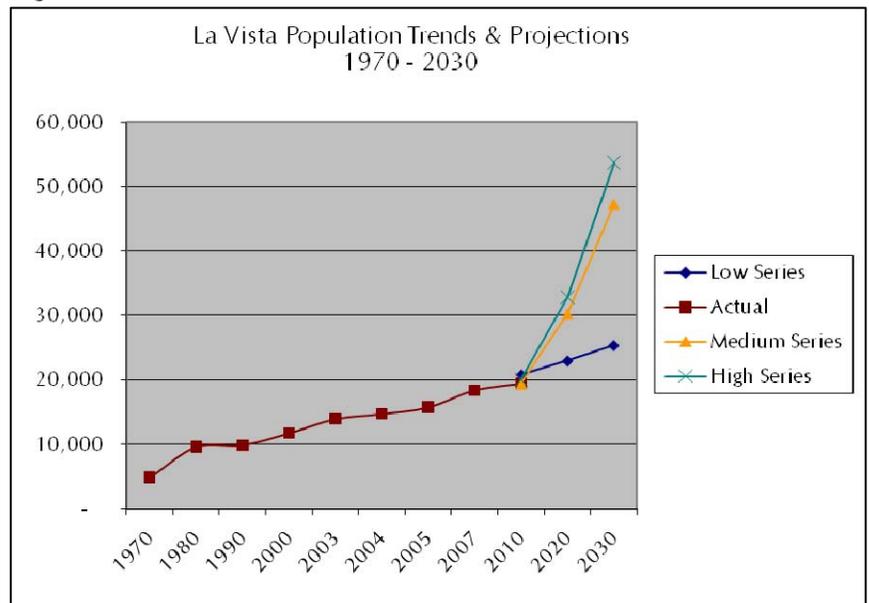
Two methods were used to analyze La Vista’s population growth over the next twenty years. First, illustrated in Figure 3.1.1 is based on a combination of US Census data for the City of La Vista and projection compiled by La Vista’s Community Development Department. This projection method indicates a high, medium and low series and provides a possible range of population growth for the City. The second method, Figure 3.1.2 is based on US Census data and the newly adopted annexation plan with existing and build-out population associated with

Source: US Census and La Vista Community Development Department.

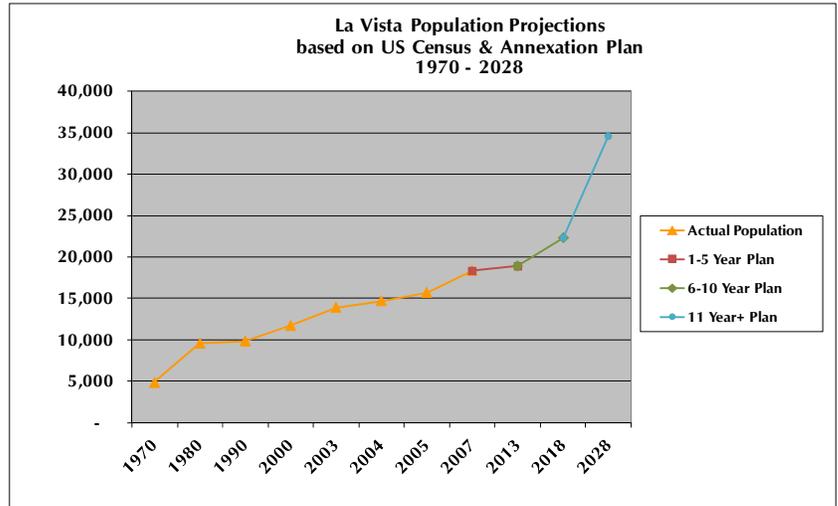
Figure 3.1.2

Source: US Census and City of La Vista, Summary of Subdivision, dated 2/26/08.

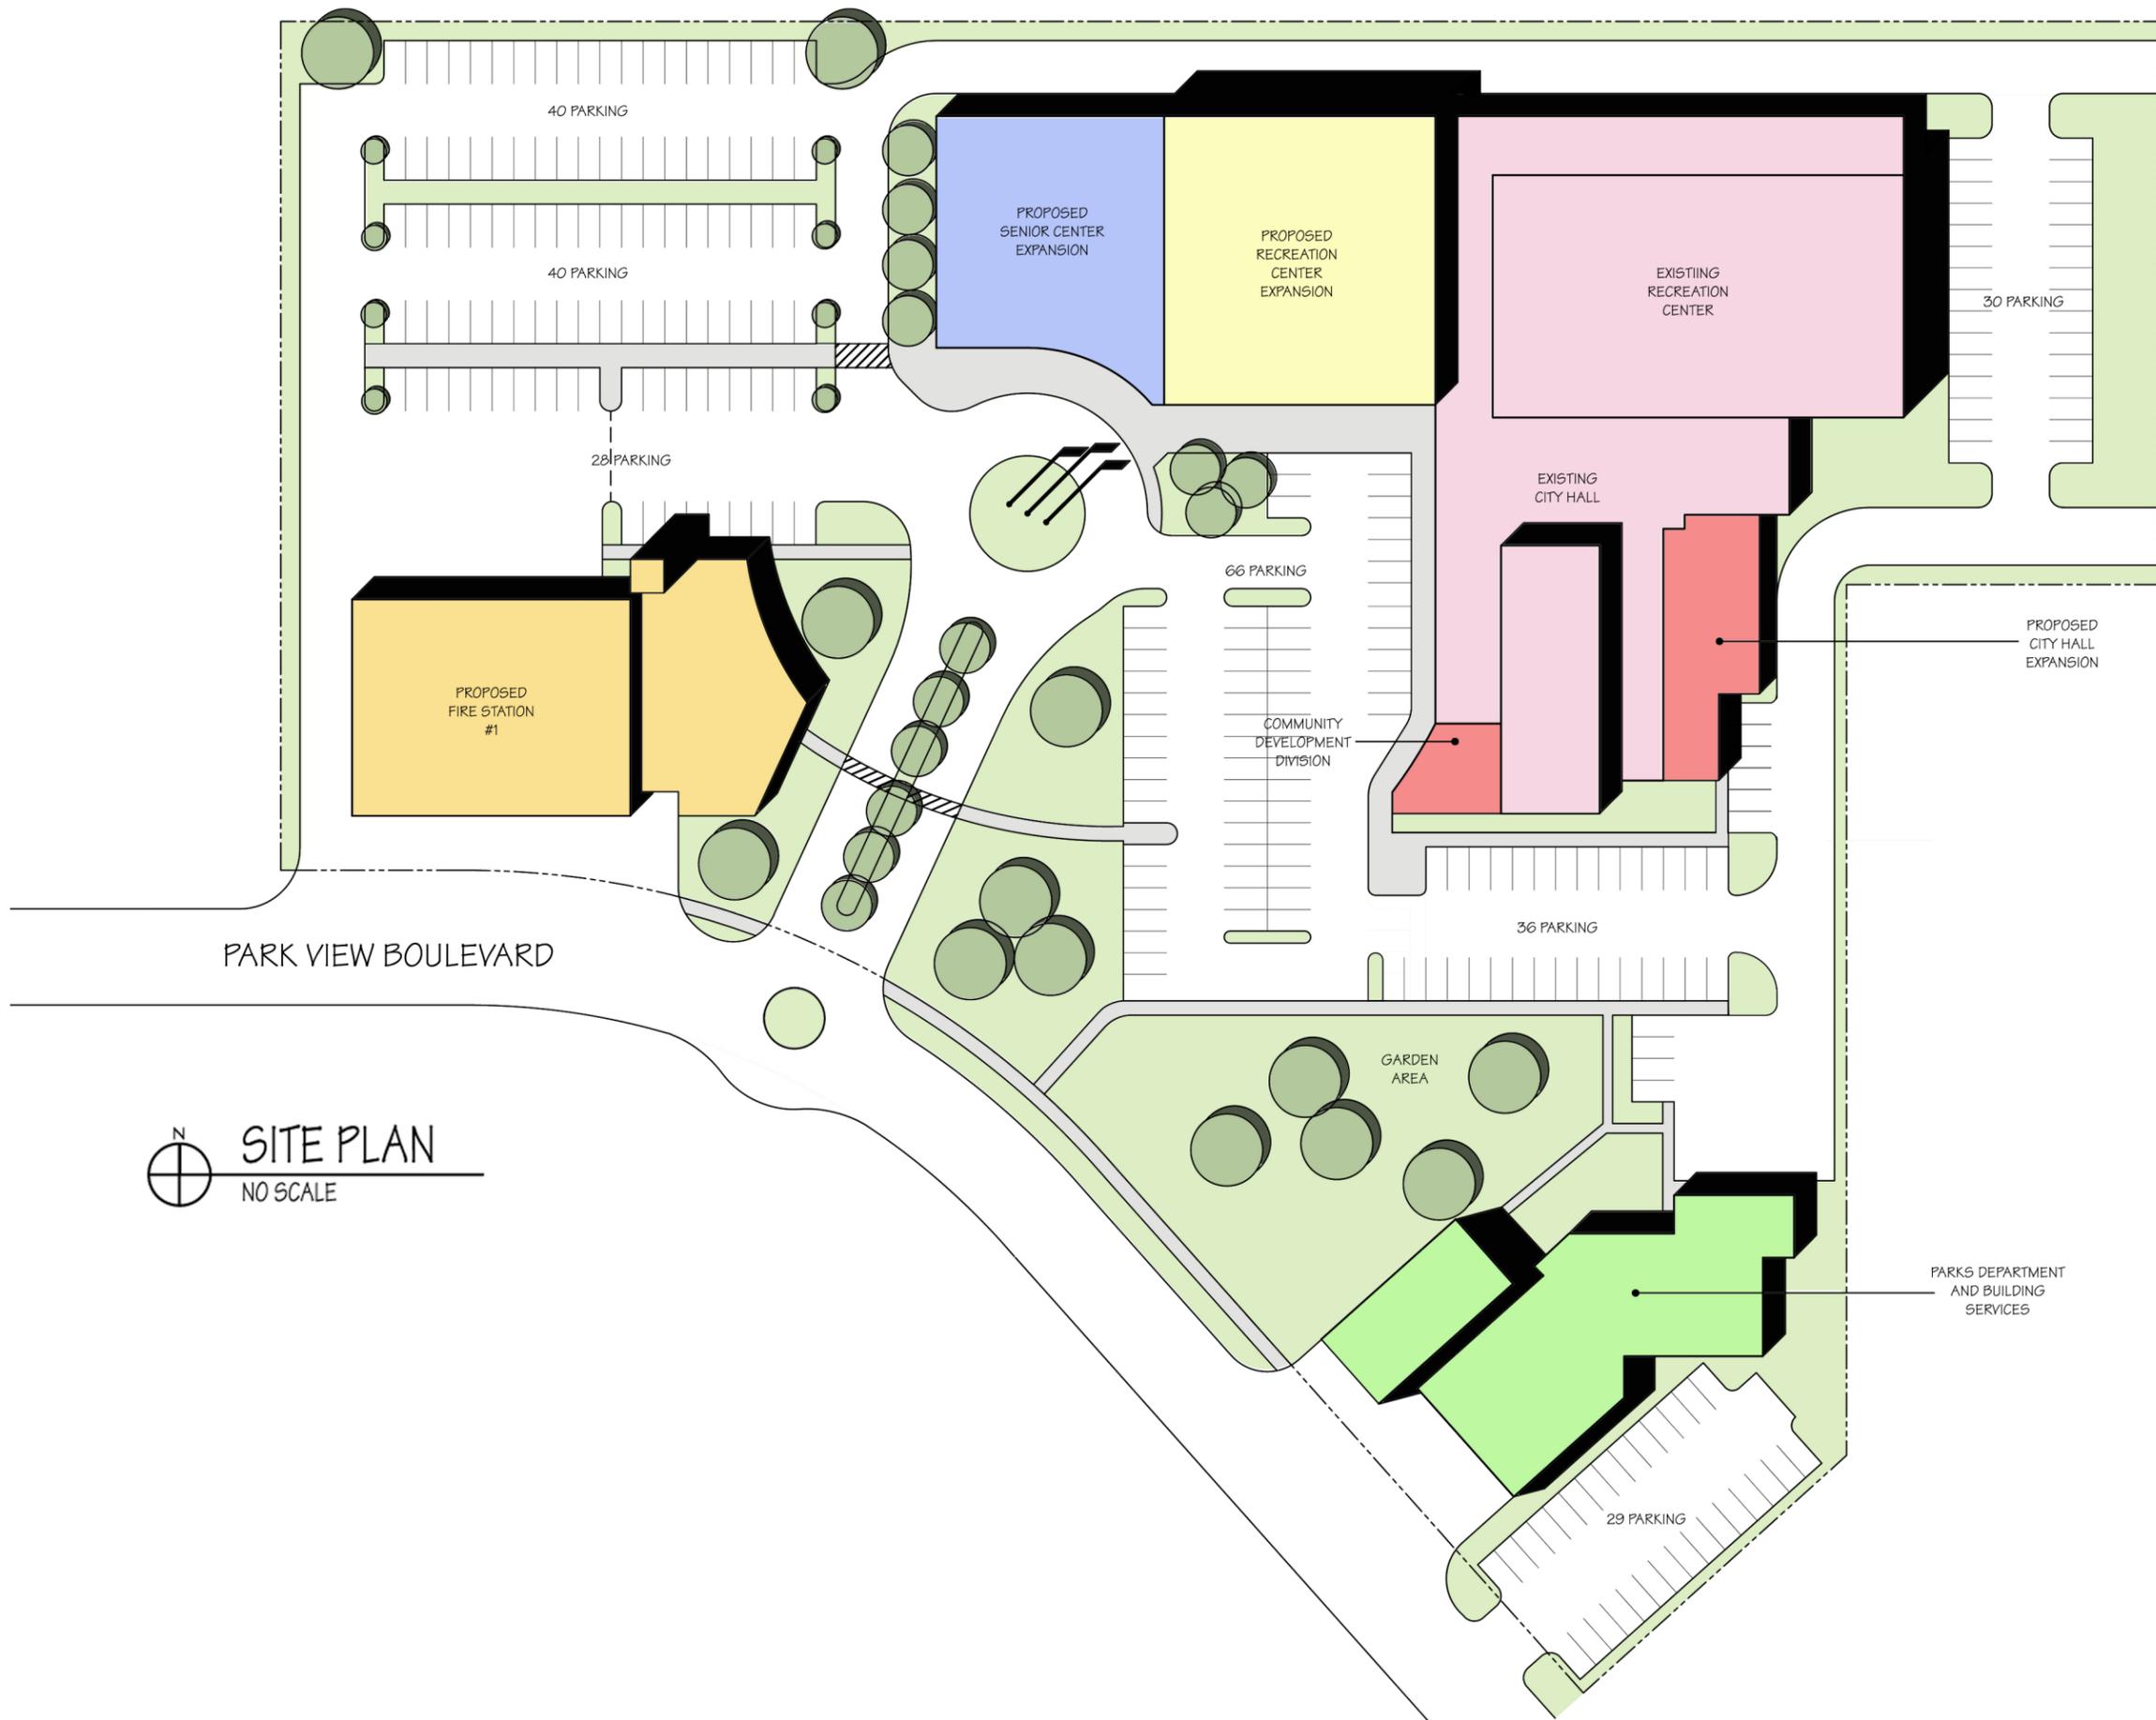
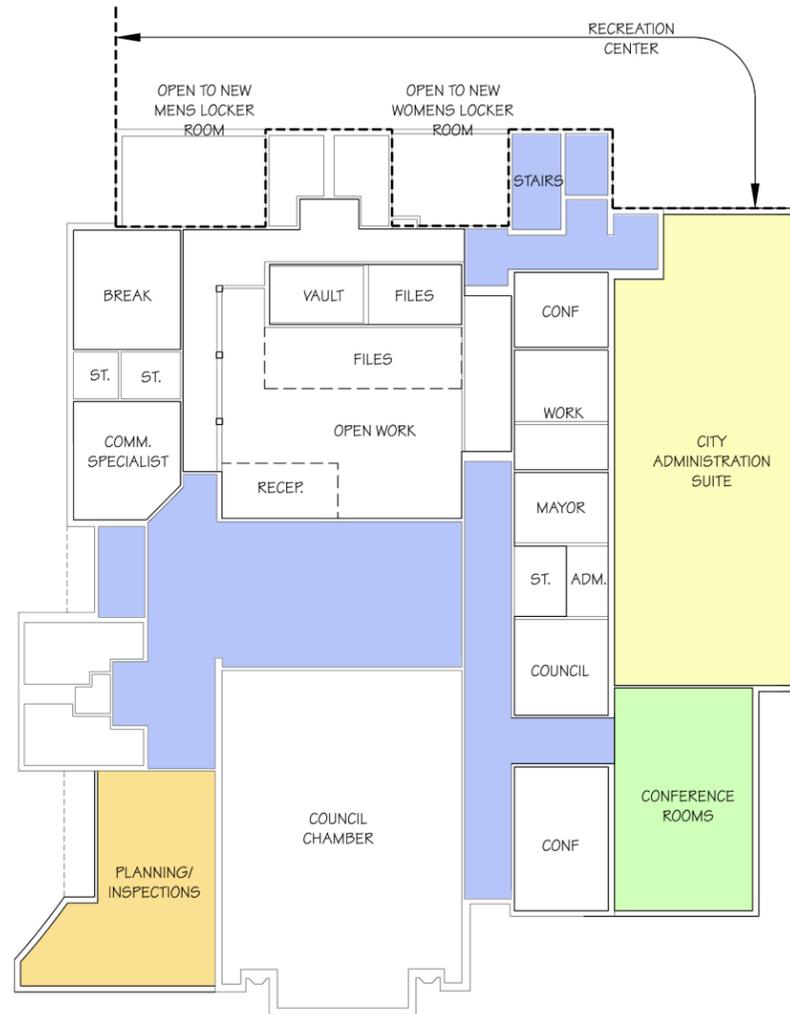
N  
SITE PLAN  
NO SCALE

Site Forces Diagram

- PLANNING AND INSPECTIONS**
  - PLANNING DIRECTOR
  - STAFF PLANNER
  - FLEX SPACE
  - INSPECTORS WORK STATION
  - PLANS STORAGE

- ADMINISTRATION SUITE**
  - CITY ADMINISTRATOR
  - ASST. CITY ADMIN
  - H.R. ASSISTANT
  - FINANCE DIRECTOR
  - CITY CLERK
  - OPEN OFFICE
  - BREAK/WORK
